**CALIFORNIA COASTAL COMMISSION**

April 13, 2011  
 Revised April 18, 2011

**THE TOHOKU TSUNAMI OF MARCH 11, 2011: A PRELIMINARY REPORT  
 ON EFFECTS TO THE CALIFORNIA COAST and PLANNING IMPLICATIONS**

To: Coastal Commissioners and interested parties  
 From: Lesley Ewing, PE, Sr. Coastal Engineer

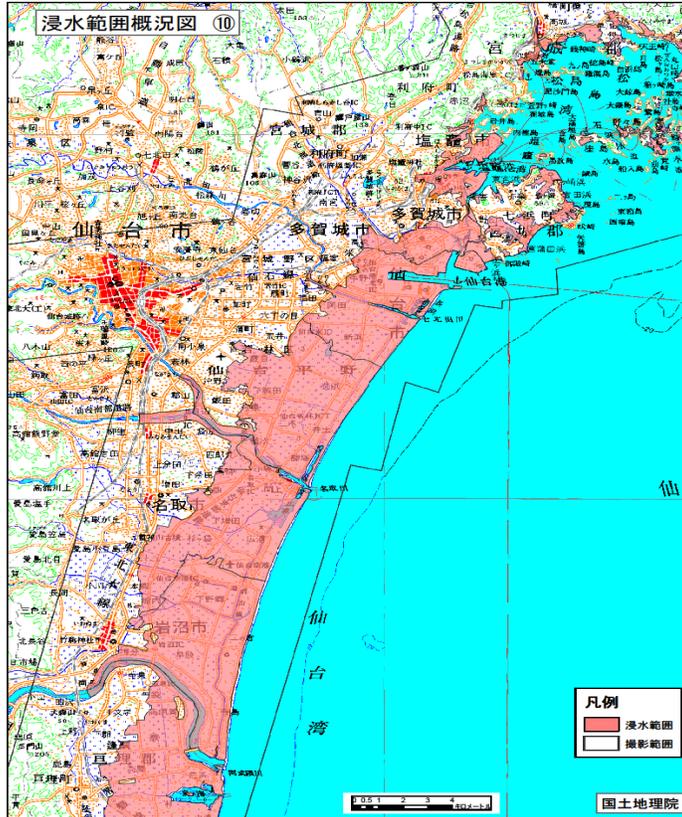
Figure 1: This map shows the inundation area near Sendai, Miyagi. Scale is shown in the bottom of the figure in kms; each small block is one kilometer.

The Tohoku Earthquake occurred on March 11, 2011, and ground shaking was first felt on the Japanese mainland at 3:46 PM local time and continued for up to 5 minutes. The earthquake occurred along a subduction zone between the Pacific and North American plates, approximately 81 miles (130 km) offshore on the Oshika Peninsula in northern Japan. A tsunami was generated by the earthquake and damaging waves started washing over the Japanese coast within 15 minutes of the seismic event. Over the ensuing hours, waves reached 1 to 3 miles (3 – 5 km) inland, often extended up to 35 feet (10 meters), and with runup reaching 80 to 100 feet (25 to 30m). Figure 1 shows the inundation zone near Sendai, Miyagi Prefecture.

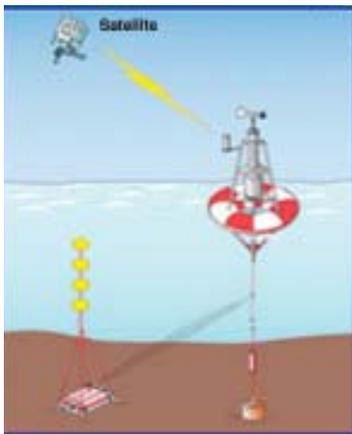
Even though tsunami waves in the open ocean do not create large changes in water level, they create a change in water pressure that can be detected by the bottom-mounted pressure sensors in the DART array. Information from the DART buoys is sent to both the West Coast and Alaska Tsunami Warning Center (WCATWC) in Palmer, Alaska, and the Pacific Tsunami Warning Center (PTWC) in Ewa Beach, Hawaii. The WCATWC sends tsunami information and bulletins to California, Oregon, Washington, British Columbia, Alaska, and the US eastern seaboard; the PTWC sends tsunami information and bulletins to Hawaii and all other parts of the Pacific and Indian Oceans. The tsunami warning centers use four tsunami alert levels, in descending order – **warning, advisory, watch and information only**.

Fig. 2. DART buoy and satellite system; Figure 3. DART network, <http://www.ndbc.noaa.gov/dart.shtml>

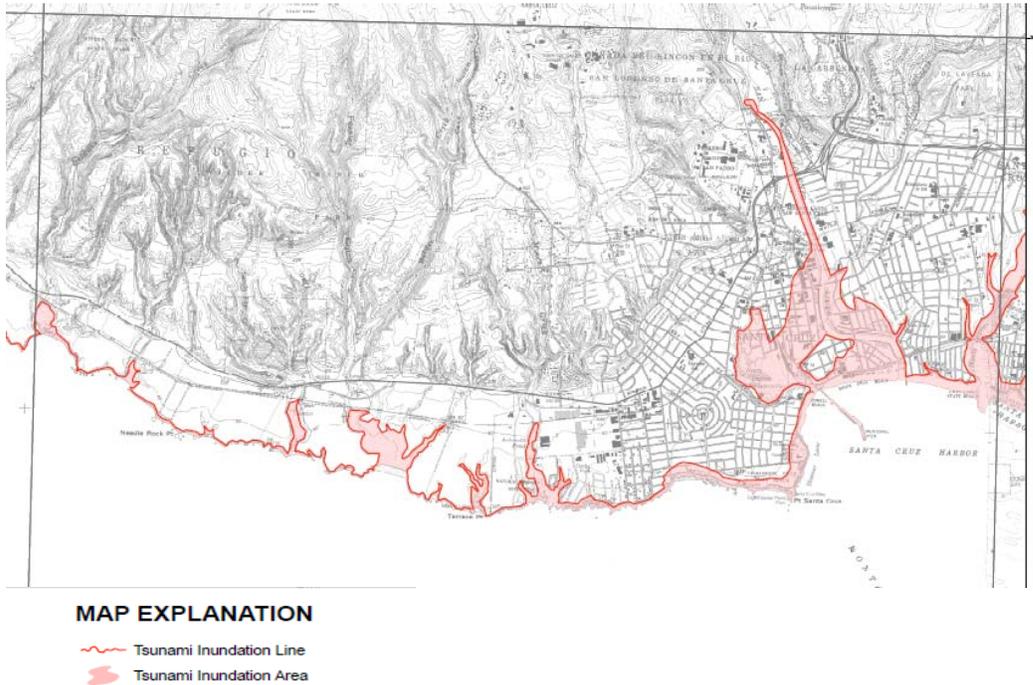
Figure 4: Excerpt of the tsunami inundation map for area near Santa Cruz Harbor. See full map display at [http://www.conservation.ca.gov/cgs/geologic\\_hazards/Tsunami/Inundation\\_Maps/SantaCruz/Documents/Tsunami\\_Inundation\\_SantaCruz\\_Quad\\_SantaCruz.pdf](http://www.conservation.ca.gov/cgs/geologic_hazards/Tsunami/Inundation_Maps/SantaCruz/Documents/Tsunami_Inundation_SantaCruz_Quad_SantaCruz.pdf) for method of preparation, purpose for the maps, tsunamigenic events that were considered in developing the map, disclaimer on use and full reference.

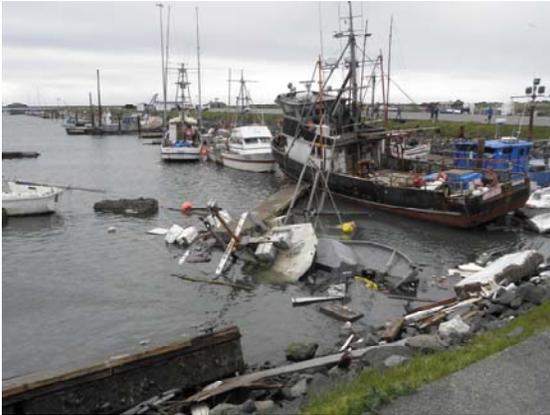
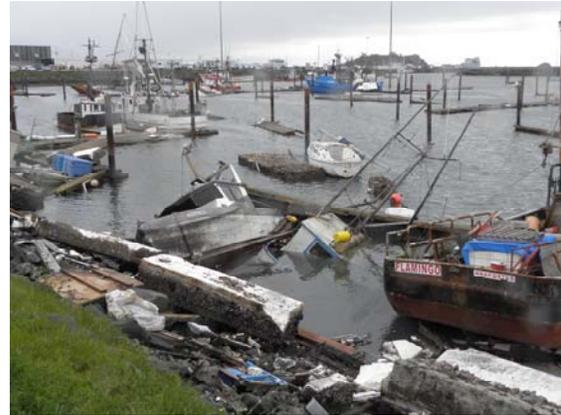
Harbors experienced damage to docks and piers and some of the boats that remained in the harbors and marinas were swamped, capsized, sunk or damaged. Figures 5 and 6 show some of the damage at Crescent City. If mooring lines or dock connections were not strong enough to withstand the currents, boats or pieces of dock would break free and

become floating debris. The floating debris then contributed to the damages as it rammed into boats or docks that had not been damaged by the initial currents.

Figures 5 and 6: Crescent City Harbor, March 12, 2011 after the tsunami.

*Significant Commission Actions:* The most apparent damage in the harbor was to the docks and pilings. Prior to the 2011 event, the 2006 tsunami from the Kuril Islands tsunami had caused approximately \$20 million in damages to the docks and some of the pilings. At its February 2011 hearing, the Commission approved a permit to replace the docks and pilings and to add a wave attenuation wall just south of Pier H. The attenuation wall might have reduced the currents and eddies in the Inner Harbor. The new docks and pilings were designed for wave heights in excess of anything in the harbor and for currents slightly higher than to those experienced in the harbor from the Tohoku tsunami. Work was scheduled to begin this spring and, once the harbor is cleared of debris, the new dock and pier work may be able to start, assuming no new work is necessary. At earlier hearings, the Commission had approved permits to do repair and maintenance on the rock slope protection within the larger harbor area and to do repair and maintenance on a section of the breakwater. While the extent of new damage to the rock slope protection and the breakwater is not known, it is possible that the repair work is within the areas already covered by Commission permits.

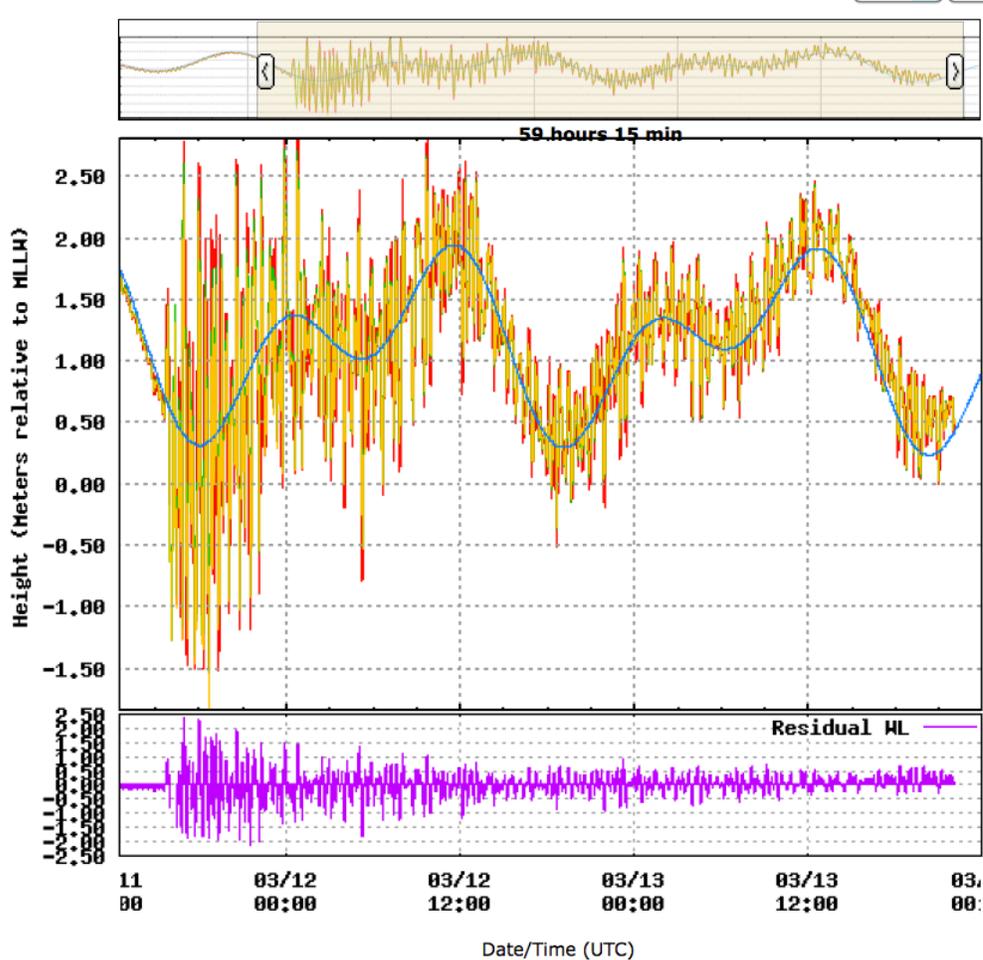
**Crescent City:** Maximum wave amplitude was 8.1 feet (2.5 m) and it arrived at the harbor at 8:56 AM. Eye witness accounts estimated that currents in the harbor were about 20 knots (23 mph). Strong surge was still noticeable more than a day and a half after the first wave arrived in the harbor. The majority of the damage occurred within the Harbor, at the Inner Boat Basin and at Elk Creek. South Beach, south of Crescent City Harbor, had a large amount of Styrofoam debris that, most likely, had been torn from the floating docks in the Inner Harbor by a tsunami wave and carried from the Inner Harbor to the beach by subsequent waves.

Water levels for 9419750 - Crescent City  
From 03/11/2011 01:17 through 03/14/2011 01:17  
Disseminating sensor: A1 | Alternate sensor: B1 | Datum: MLLW

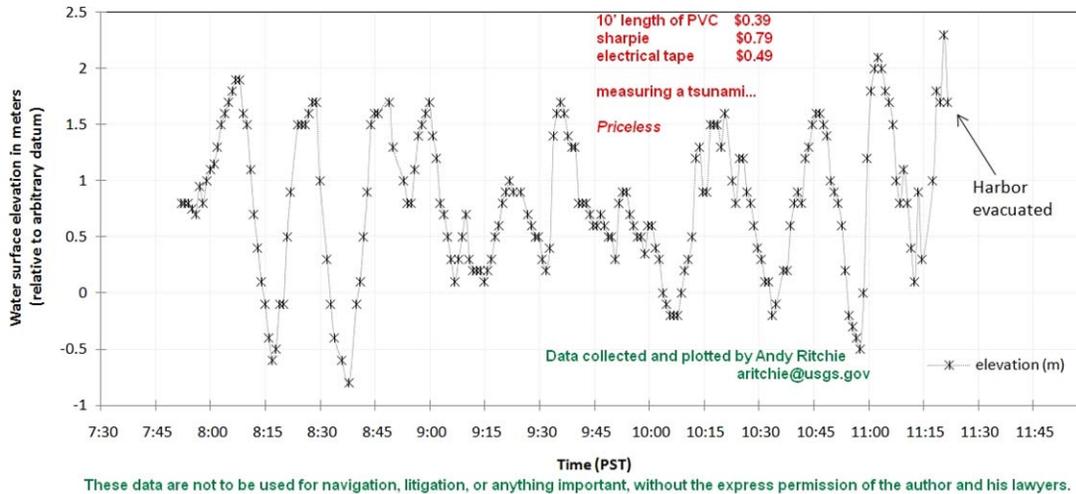
Figure 8: Santa Cruz Harbor Tsunami Amplitude; morning of March 11, 2011  
Data and plot courtesy of Andy Ritchie, USGS Pacific Coastal & Marine Science Center, Santa Cruz, CA
