Fresh & Easy Neighborhood Market, Waiver

800 Pacific Coast Highway, Seal Beach, Orange County

Permit/LCP #: Waiver# 5-11-199

Site Visit: Staff: Tamara Doan Date: May 10, 2012

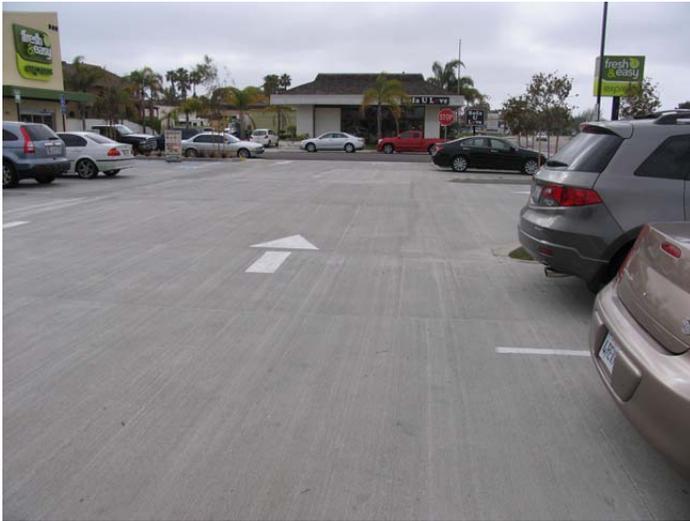
Photo 1.
Fresh & Easy Market porous concrete parking lot
(view north to 8th Street; parallel to PCH).

BMP #	Description	Observations *	Grade */ Follow Up
1	Paved areas are porous to allow for infiltration	The majority of all paved areas were constructed with 4" of porous concrete. There was one small area (approx, 2 parking spaces) constructed of traditional PCC, which covered the power, water/sewer infrastructure, as were the curbs and new sidewalks constructed around the building and along PCH and 8 th Street. [Photo 1]	A

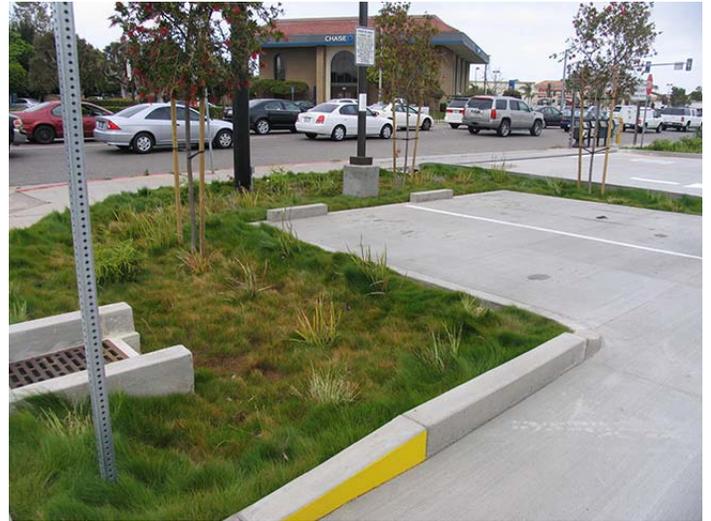
Photo 2.
Any surface runoff that does not percolate through the porous concrete of the parking lot freely drains into a grassed wetland area (view looking east toward PCH).

BMP #	Description	Observations *	Grade */ Follow Up
2	Paved areas are connected to vegetated infiltration areas	All parking and driveway areas were graded so they drained to the vegetated swale areas. The drain inlets along PCH were directed to vegetated areas along the sidewalk. [Photos 2-7] The side loading area (along a service alley) were graded to the rear corner so they would flow into a 'rain garden' which consisted of a cobble 'stream' and wetland grasses and plants along the side of the project building and the adjacent property's cinderblock wall [Photo 6-7]. This area was continuous across the property, from the alley to the sidewalk in/outlet on 8 th Street. A small amount of water was observed in the driveway area during the visit, which was flowing toward the slot drain. [Photo 4]	A
3	Structure downspouts (roof/building runoff) is connected to vegetated infiltration areas	Downspouts from the building were observed along 8 th Street and at the rear of the building. As well, there were 'cooling unit discharge' drains (from the refrigerators inside the market, per market staff) which were also connected so as to discharge to the rear vegetated area. The PCH (front) 'wetland' and the rear 'rain garden' vegetated areas both contained appropriate plants which were all healthy and well tended. The 8 th Street landscaped area along the side of the building had fewer plants and was appropriately mulched. No areas showed signs of erosion or drying to date; however this site visit was conducted within less than six months of installation. [Photo 9-10]	A

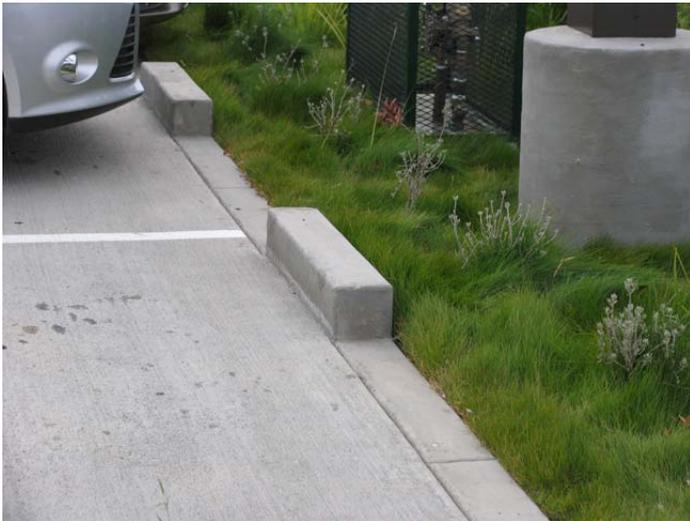
Photo 3.
The parking lot is graded so that all surface runoff from to driveway and areas under parked cars is directed to vegetated areas for infiltration.

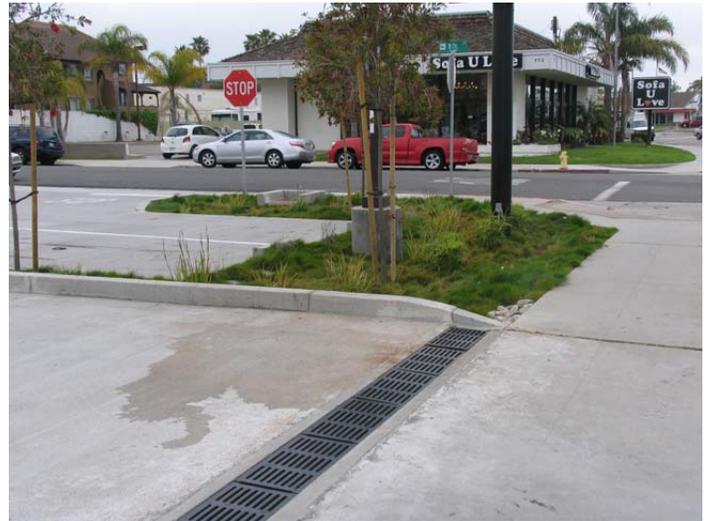
Photo 4.
Any surface water leaving the property via the driveway, or flowing from the public sidewalk toward the property will drop into a slot drain and then be deflected to the grassed areas to the left and right of the PCH Entrance (view from sidewalk on PCH to 8th Street).

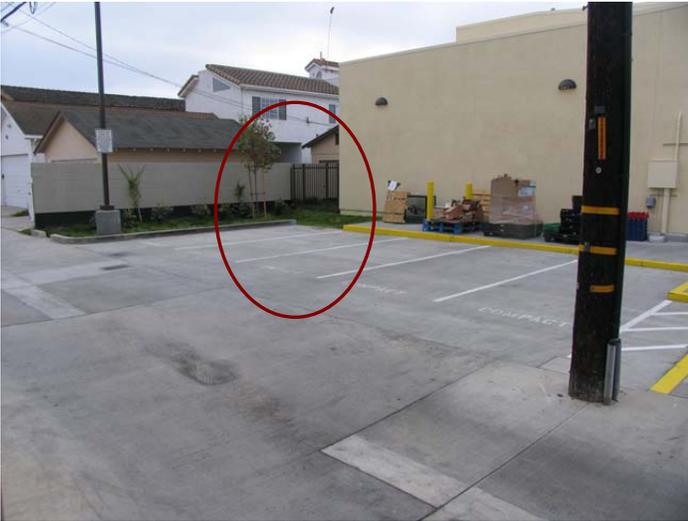
Photo 5.
This loading area on the alley is graded so it drains to a vegetated bioswale, or 'rain garden,' area behind the building (towards the upper left of this photo). The alley itself predominantly drains to the municipal storm drain system on PCH.

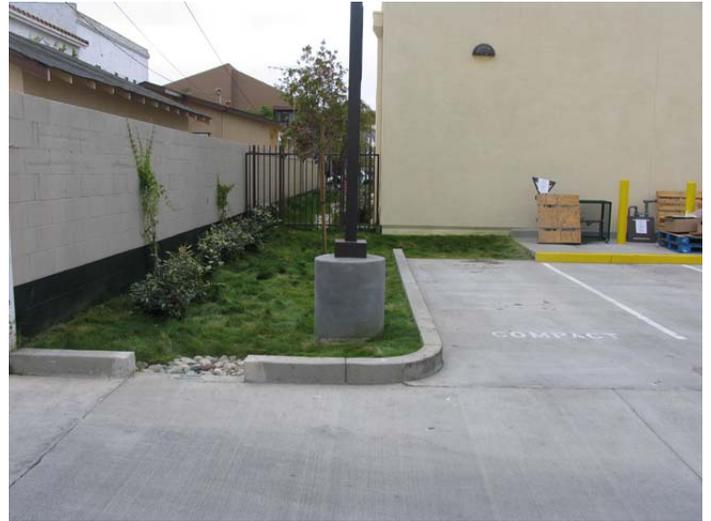
Photo 6.
There are inlets for flows from the truck parking area and the alley overflow to enter the vegetated area behind the building.

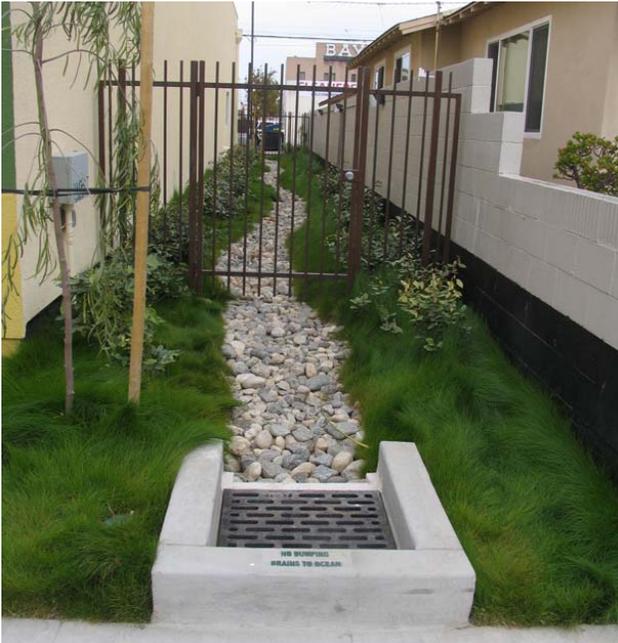
Photo 7.
The rear 'rain garden' or bioswale infiltration area is continuous between the alley and 8th Street; when saturated it can also overflow out to the streets and the municipal storm drain system.

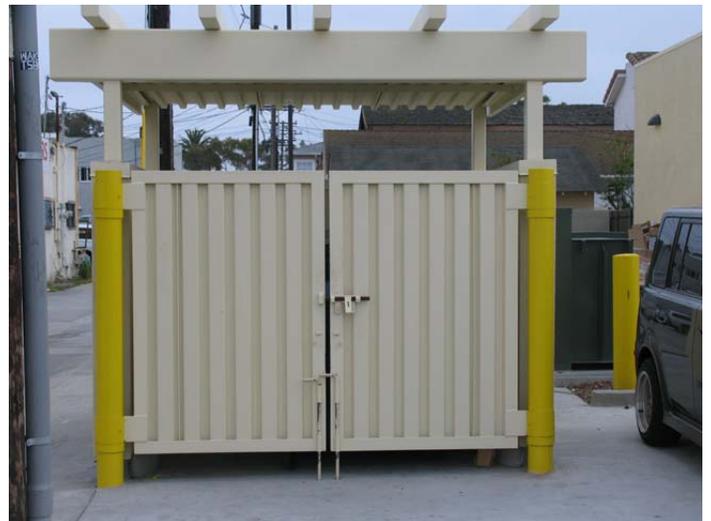
Photo 8.
Trash dumpsters are stored in an enclosed area along the alley. No trash was observed on the ground at the property during the site visit. No drain for liquid discharges was observed.

4	Trash collection areas are enclosed	The commercial dumpster was housed in a secure, weather protected, structure which prevented exposure to rain or wind, or to scavenging by the public. There was however no visible connection to any drain or sanitary sewer connection for liquid discharges from the dumpster. [Photo 8]	B
<p>Grades in relation to CCC and RWQCB requirements: A - Clearly Exceeds Reqts.; B- Clearly Meets Reqts.; C - Appears to Meet Reqts. (Need Info); D - Does Not Appear to Meet Reqts. (Need Info); F - Clearly Does Not Meet Reqts. (Consider Enforcement)</p> <p>Follow up (details for follow up in the Comments Section: None required; Date by which follow up is recommended; Enforcement recommended; Other.</p> <p>* Observations include Plan Review information for inaccessible areas of the project.</p>

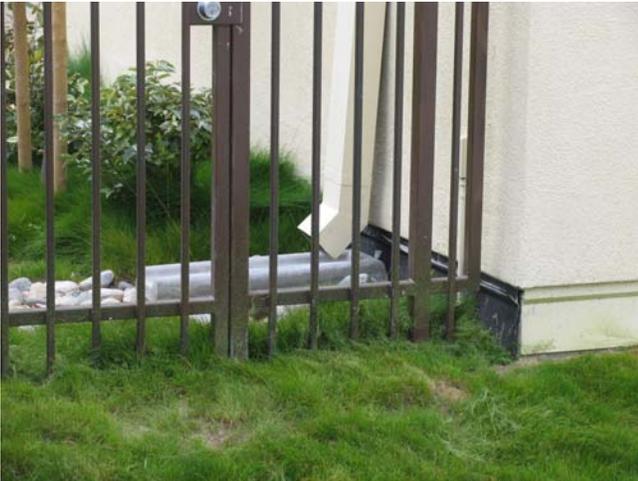
Photo 9.
Downspouts along the rear of the building have been directed to vegetated areas for infiltration.

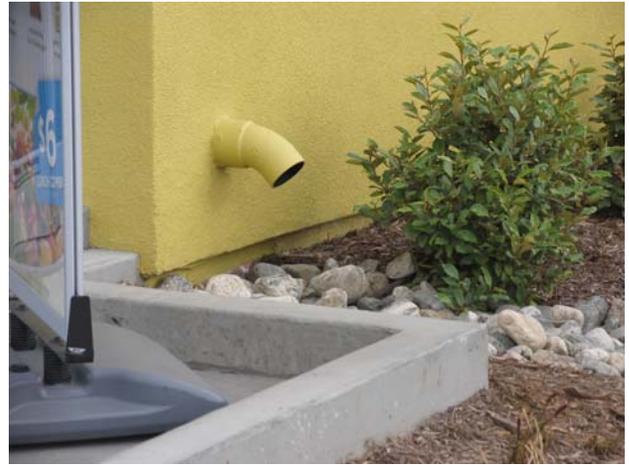
Photo 10.
Downspouts along 8th Street have been directed to vegetated areas for infiltration.

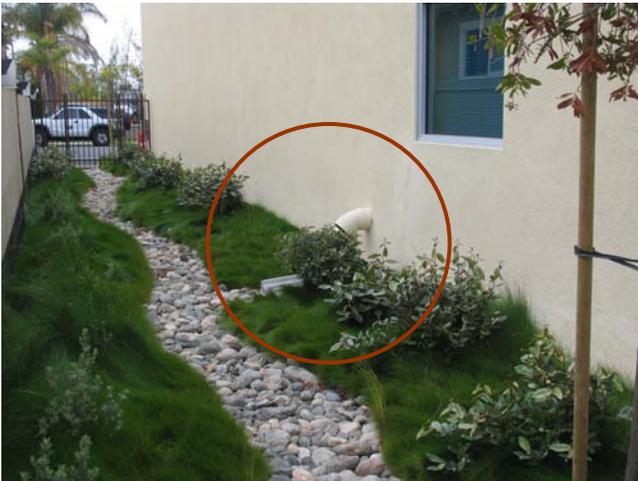
Photo 11.
The refrigerator and cooling units from inside the building have had the condensation discharge points routed to the bioswale at the rear of the building.

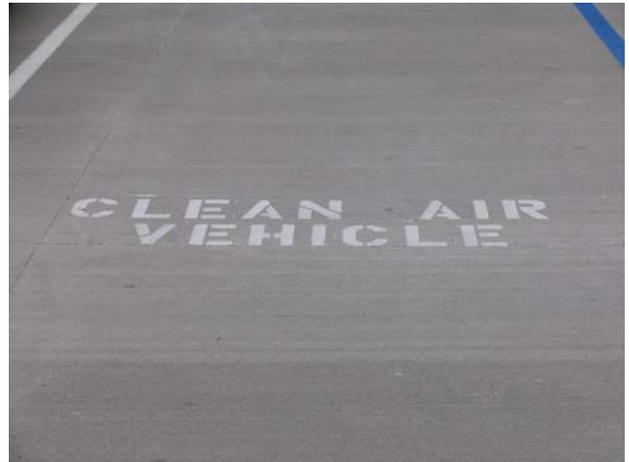
Photo 12.
One parking space, nearest the store entry, has been dedicated to clean air vehicles.

- A larger structure was developed (from 1,762 sqft fast food restaurant to a 4,320 sqft market), increasing the impervious area associated with the building.
- The project includes 3,748 sqft of driveways and 21 parking stalls; including one handicapped stall, and once "clean air vehicle" stall [Photo 12].
- Porous concrete pavement was used for the parking, driveway and loading areas, totaling 21.5% of the total project area.
- Landscaped areas are increased to be 12.9% of the property, totaling 2,244 sqft.
- All parking, driveway, and loading areas are graded so that they flow to vegetated 'wetland' treatment areas along PCH and 8th Street.
- A slot drain is placed crossing the main entryway from PCH to capture any surface runoff from the driveway and from the sidewalk along PCH. This drain then directs flows to the wetland vegetated areas to the east and west of the driveway.
