Trinidad Pier Reconstruction Project

Trinidad Harbor, City of Trinidad – May 22, 2012

Site Visit: Staff: Vanessa Metz Date: May 22, 2012

Trinidad Pier Site Visit Photos 5-22-12

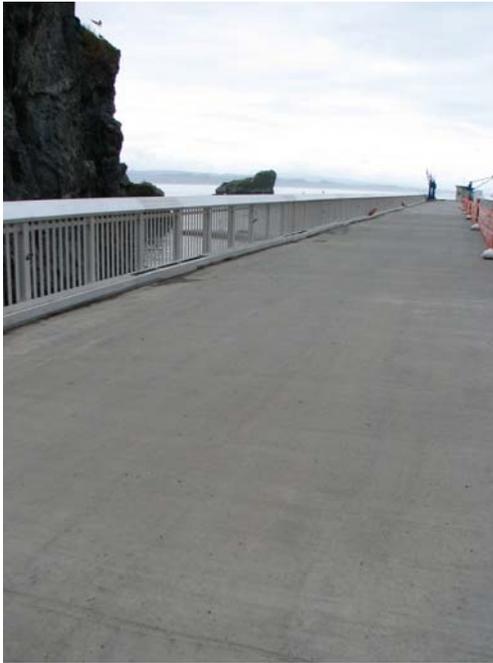
Photo 1:
Trinidad Pier looking seaward, showing impervious concrete decking and aluminum railing.

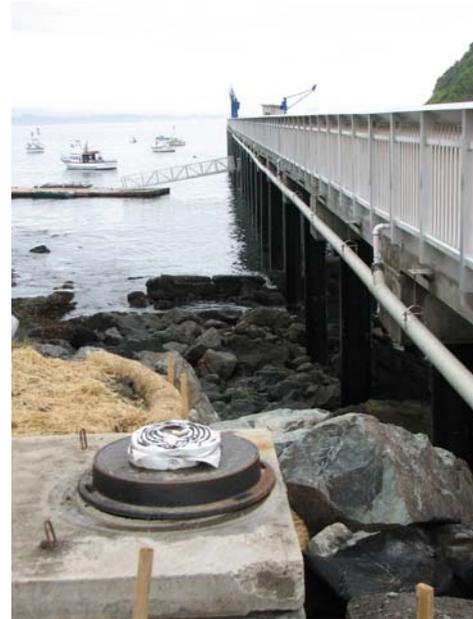
Photo 2:
Trinidad Pier looking seaward. Stormwater piping runs along the outside of the pier to the stormwater treatment vault in the left foreground.

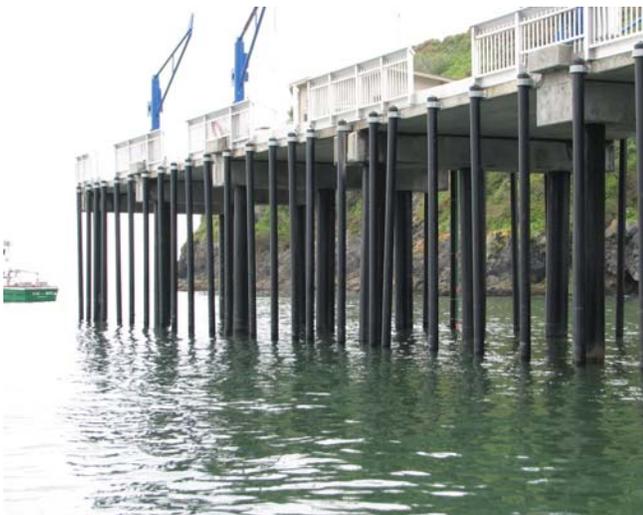
Photo 3: Polymer-coated steel-encased concrete piling supporting the pier. Two cranes are visible on the pier.

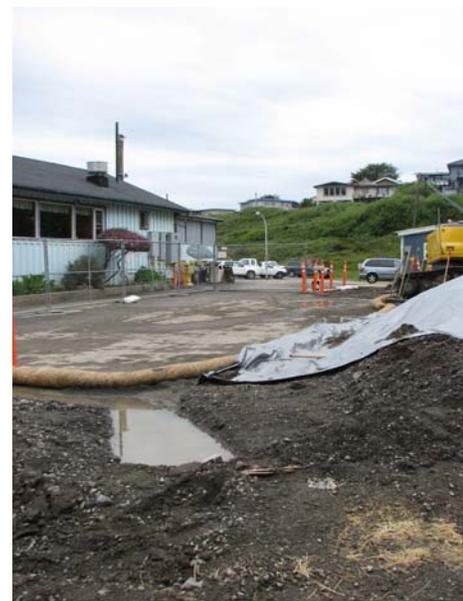
Photo 4: The paved area where the infiltration gallery for pier runoff will be located, next to the restaurant. The entrance to the pier is out of view to the left.

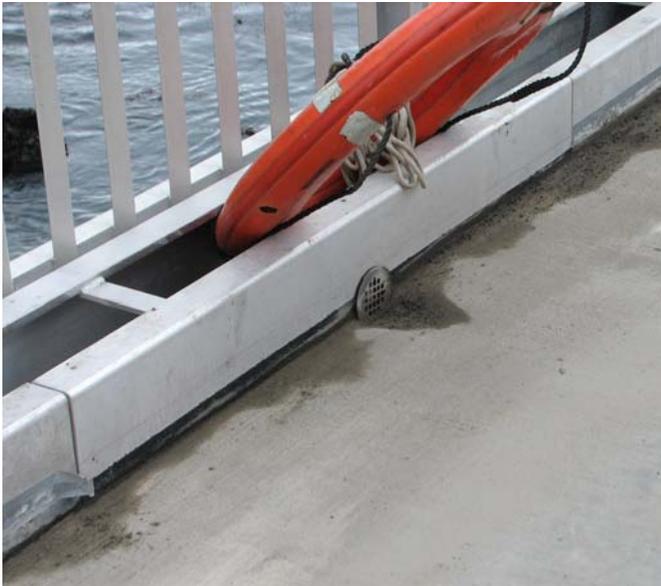
The pier’s stormwater inlets are fairly small (approximately 4-inches diameter), and the grating on the inlets appears to have rather small apertures. This may potentially lead to a problem with clogging from litter in heavy rains. A maintenance program that requires prompt inspection of the stormwater inlets during heavy rainfall would help prevent clogging. A maintenance program that regularly removes litter from the pier before rainfall events would also be beneficial.

Photo 5:
One of several stormwater inlets on the pier.

Follow-up Visit Recommended?: Yes, it would be a good idea to observe the stormwater drainage inlets during a heavy rainfall to confirm their appropriate sizing. It would also be beneficial to get a copy of the maintenance plan for the pier, when completed. A follow-up with the city to address ways to potentially contain leakage of fluids from the cranes is recommended.

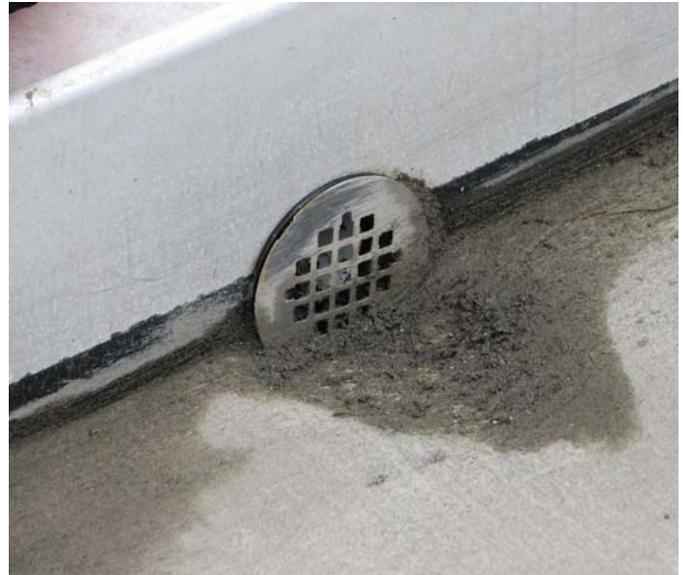
Photo 6:
Close-up of a stormwater inlet on the pier.

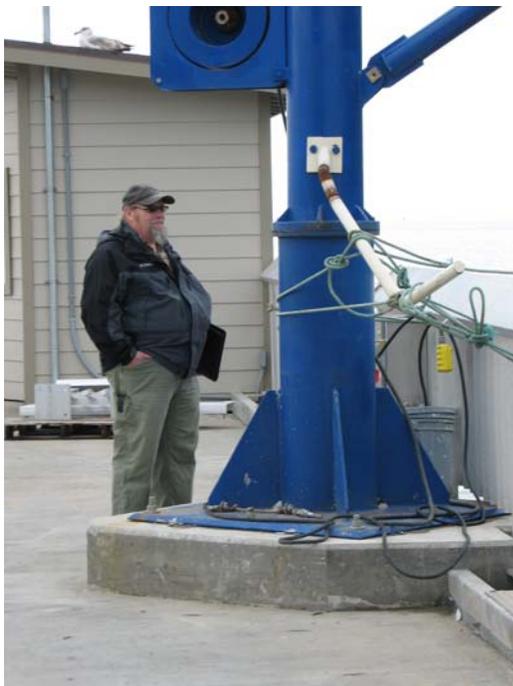
- Fish-Cleaning Waste: The fish cleaning station that was previously present on the old pier is no longer there. Fish cleaning will not be allowed on the new pier, which will reduce potential pollutants from fish waste.
- Other NPS Pollutant Sources: The drayage cranes all appeared to be oozing a small amount of lubricant from the pivot points. Each crane is installed on a concrete base, without containment for spilled lubricants and hydraulic fluids around the base of the crane. A containment system to capture drips of lubricant from the cranes would be an improvement. The use of vegetable-oil-based lubricant and hydraulic fluid could also be considered.

Photo 7:
One of several drayage cranes on the pier. Note that there is no containment at the base for spilled lubricants and hydraulic fluids from the crane.

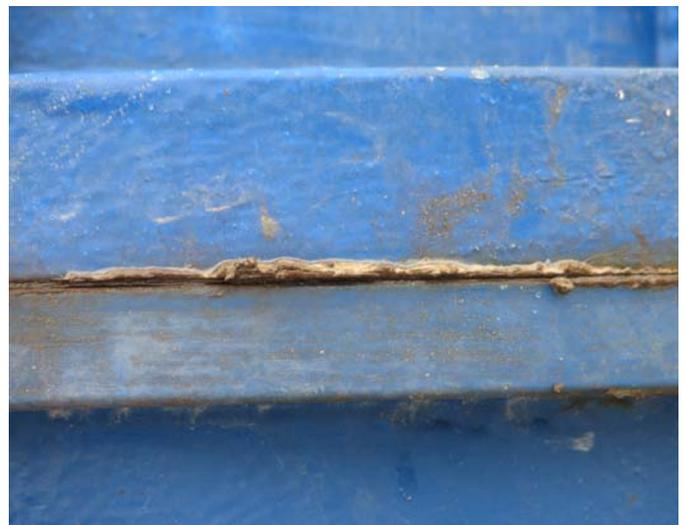
Photo 8:
Lubricant oozing from a crane on the pier.
