**US Army Corps
of Engineers**

**LOS ANGELES REGIONAL DREDGED MATERIAL MANAGEMENT PLAN
PILOT STUDIES**

LONG-TERM EVALUATION OF AQUATIC CAPPING DISPOSAL ALTERNATIVE

September 2005

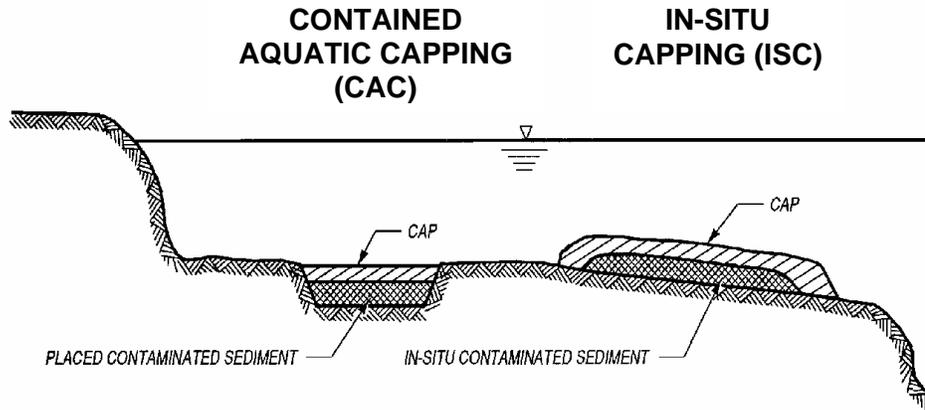
Figure 1-2
Aquatic Capping Schematic

Aquatic capping technology refers to placing a covering or cap over contaminated sediments to isolate the material from the marine environment. The cap may be constructed of clean sediments, sand, gravel, or may involve a more complex design with geotextiles, liners, and multiple layers. Two methods of capping dredged sediment are: (1) *in-situ* capping, in which a mound of dredged sediment is capped, and (2) contained aquatic capping (CAC), in which dredged sediment is placed in a depression or where other provisions for lateral confinement are made prior to placing the cap (Figure 1-2). CAC sites have been used extensively for management of dredged material in New York, Boston, Portland, Holland, Belgium, Hong Kong, New Bedford, MA, and Puget Sound for over 20 years. For example, the Boston Harbor Navigation Improvement Project (BHNIP) involved deepening of the main ship channel and three tributary channels to the Inner Harbor, and associated berthing areas. Lack of an upland disposal site and resource agency denial of permission to place and cap the contaminated sediments at an open water site resulted in the decision to use in-channel CAC cells for placement of contaminated material.

The Aquatic Capping Pilot Project was a dredged sediment capping project constructed in a depression that essentially created a CAC facility. For CAC of contaminated dredged sediments, sediments are removed from their *in-situ* location, and site evaluation issues are framed around the selection of an acceptable site for placement of the contaminated sediment and capping with clean sediment.

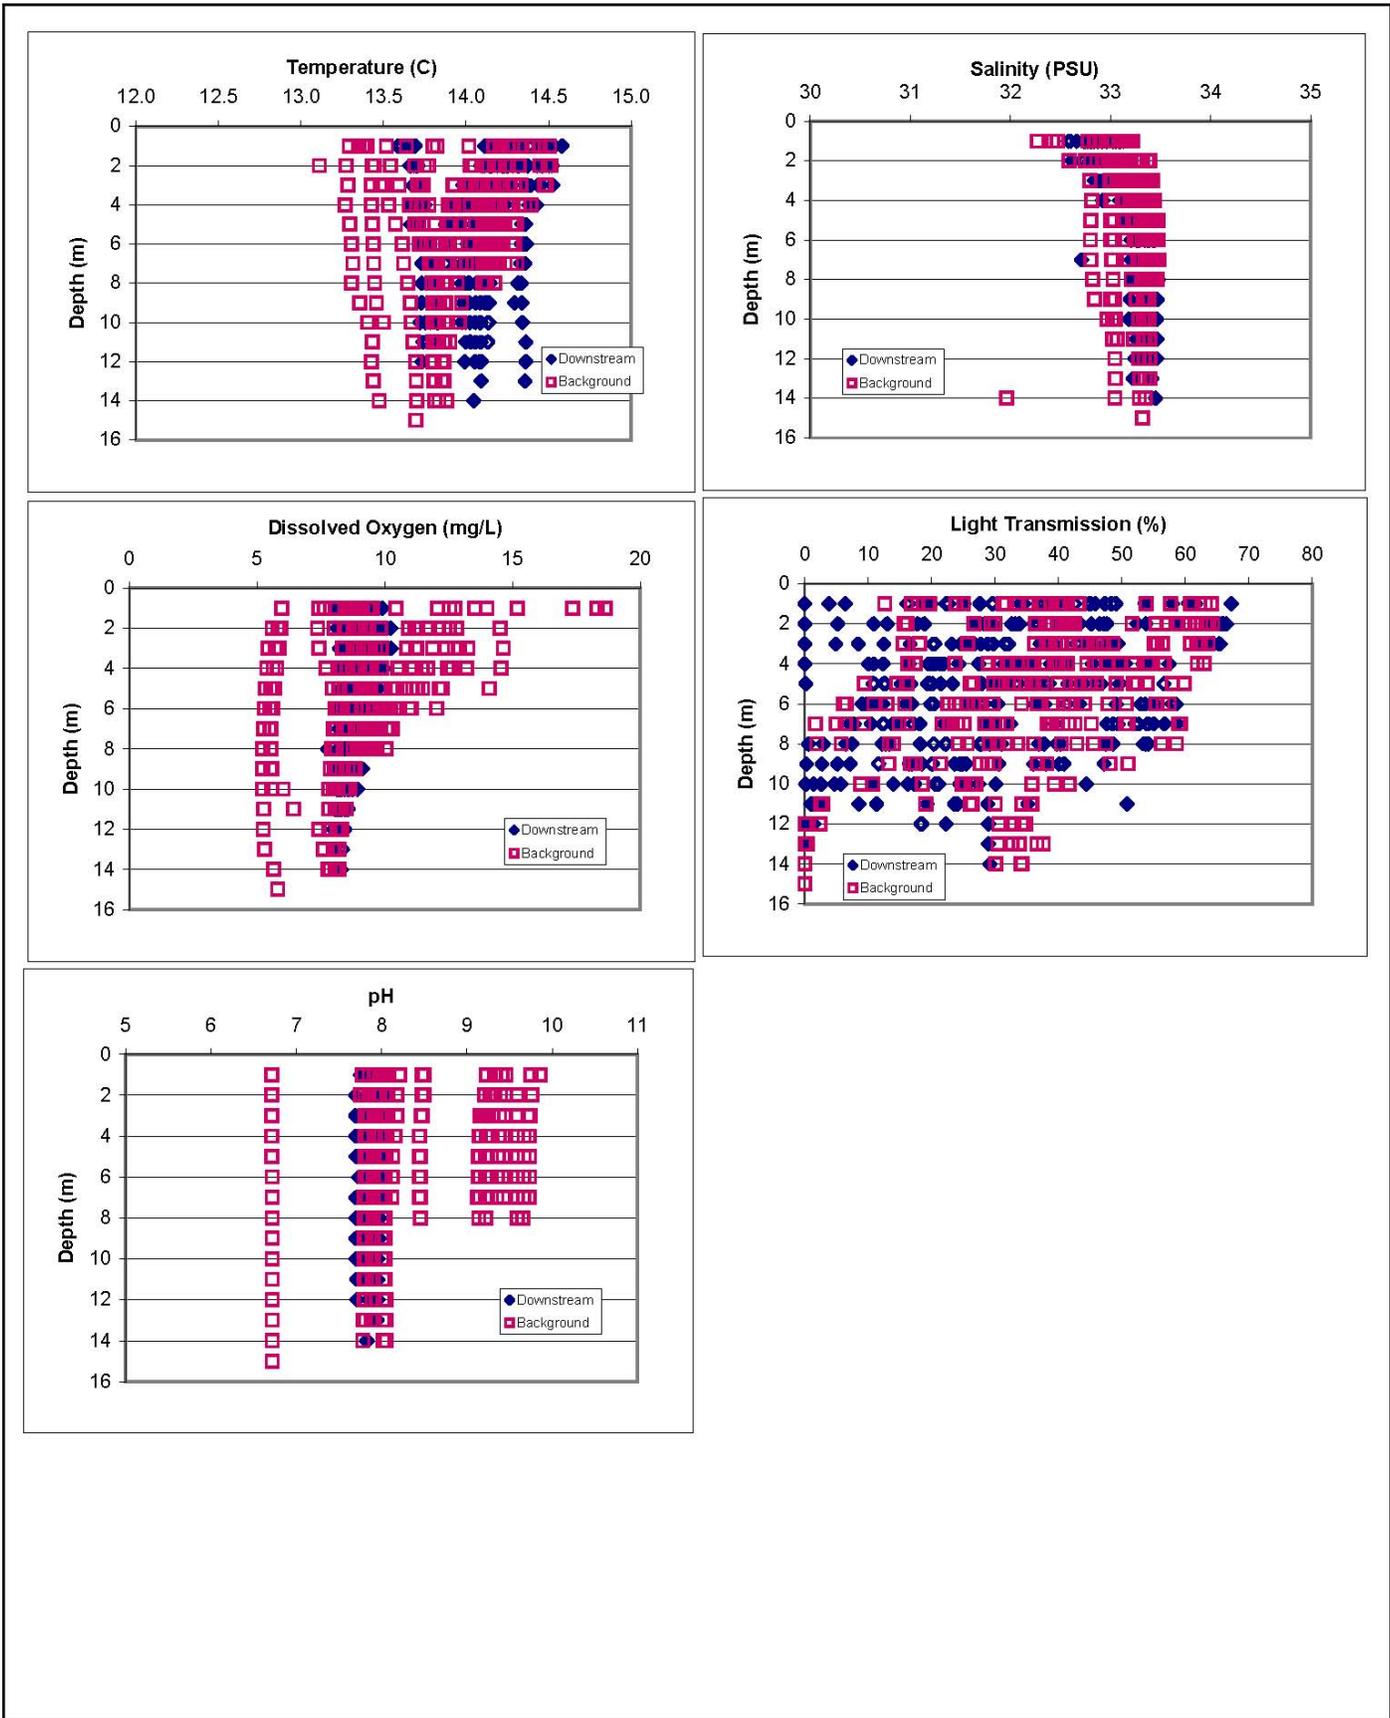
Figure 2-6
CTD Profile Data Near Cap Material Dredging Operations at the SEIBP

Profile results during dredging were similar to those found during disposal of LARE sediment at the NEIBP with little downstream variation observed in temperature or salinity (see Table 2-8, Figure 2-6). On average, dissolved oxygen was slightly depressed downstream on SEIBP cap dredging operations, but the magnitude of these changes was very small in comparison to those seen at LARE dredging and NEIBP sediment disposal operations.

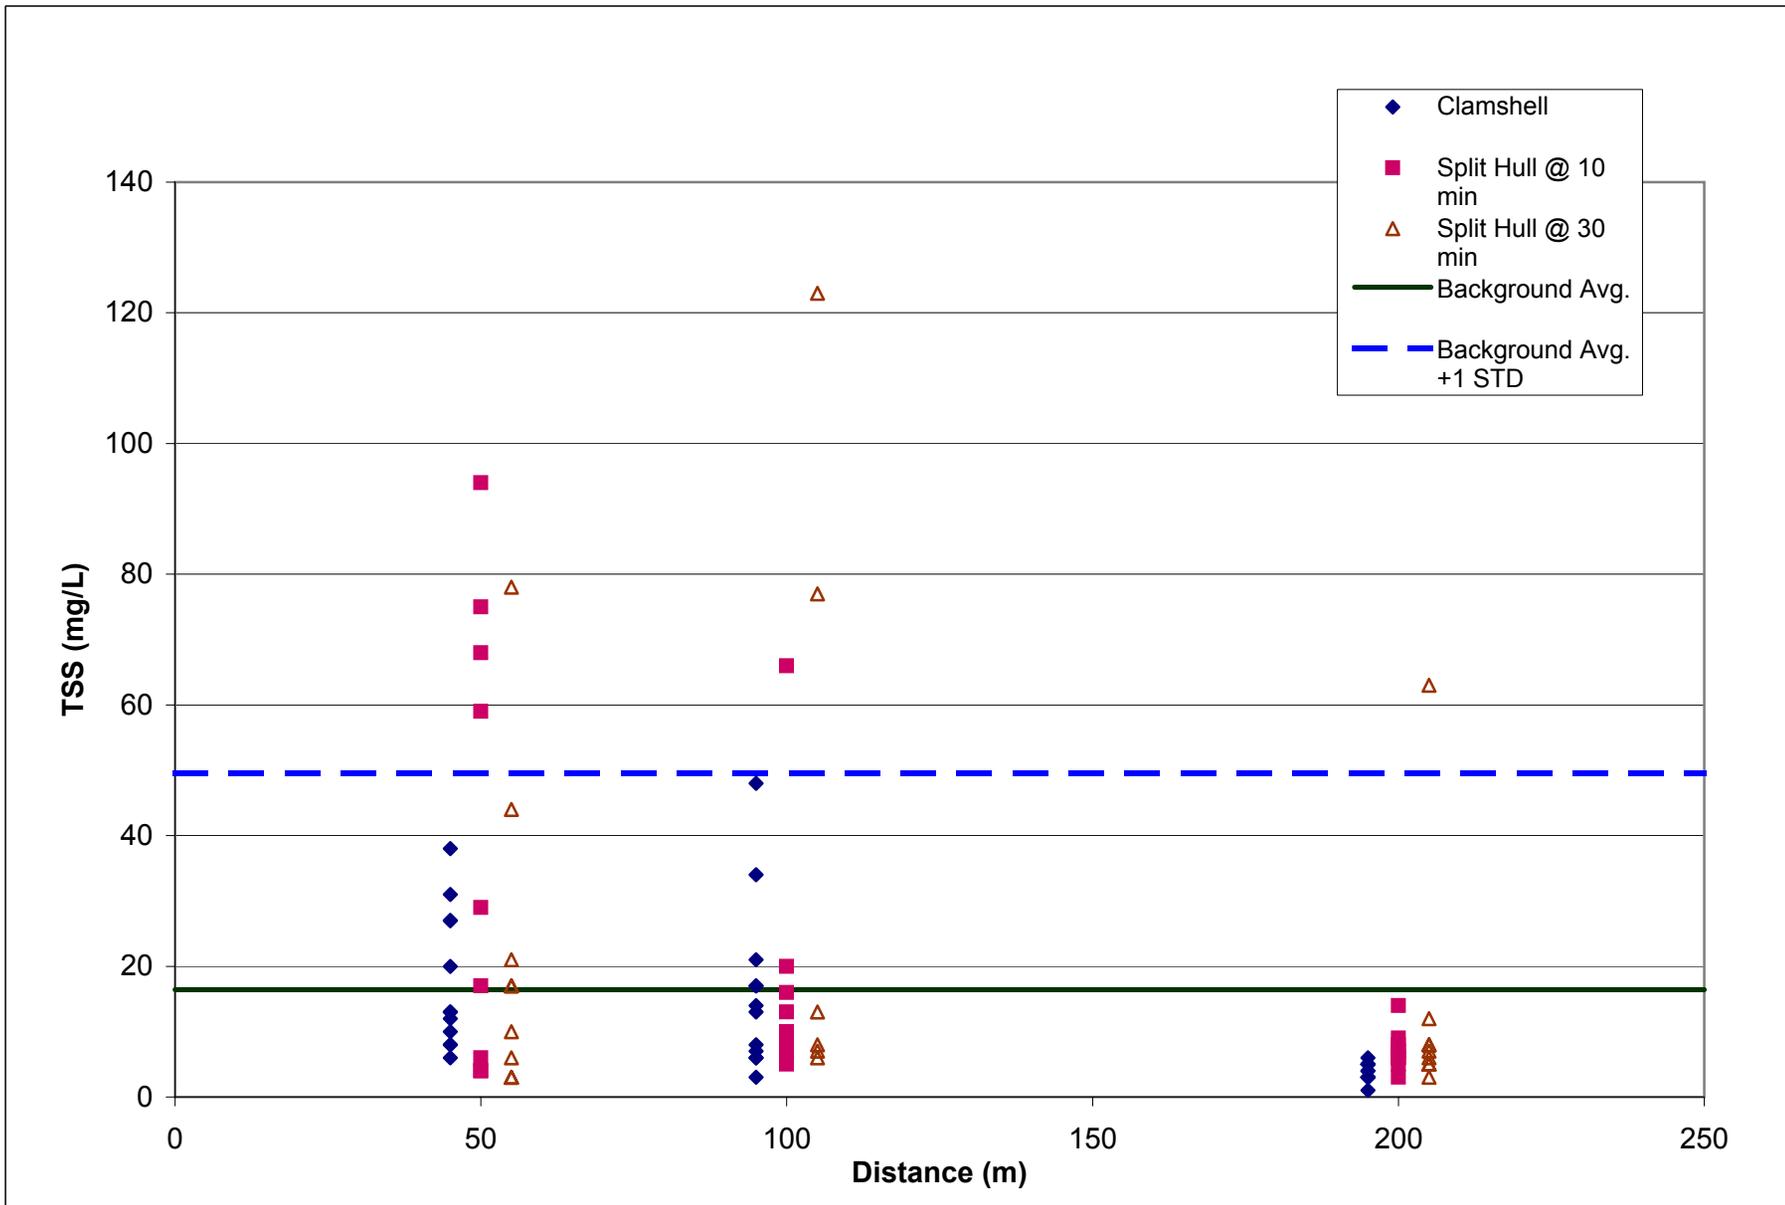
Figure 2-7
TSS Data Compared to Background - Cap Placement at NEIBP

Samples were taken from 1 m below the surface, mid-depth, and 1 m above the bottom at each station. Table 2-13 summarizes the TSS concentrations observed at downstream and background stations. Generally, for both the clamshell and split hull placement methods, the downstream TSS concentrations were within the range of typical background levels within 200 m of both placement operations. The overall spread of TSS results for clamshell versus split hull operations are shown in Figure 2-7, which shows that clamshell operations were generally within one standard deviation of the average background station. Split hull barge placement occasionally had TSS concentrations greater than this range and resulted in the nine highest observed downstream TSS concentrations.

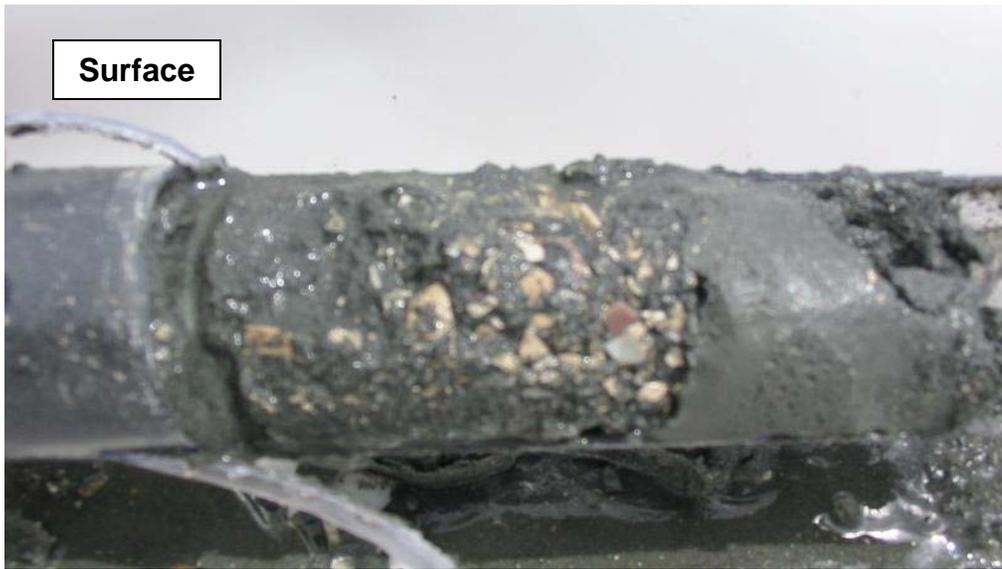
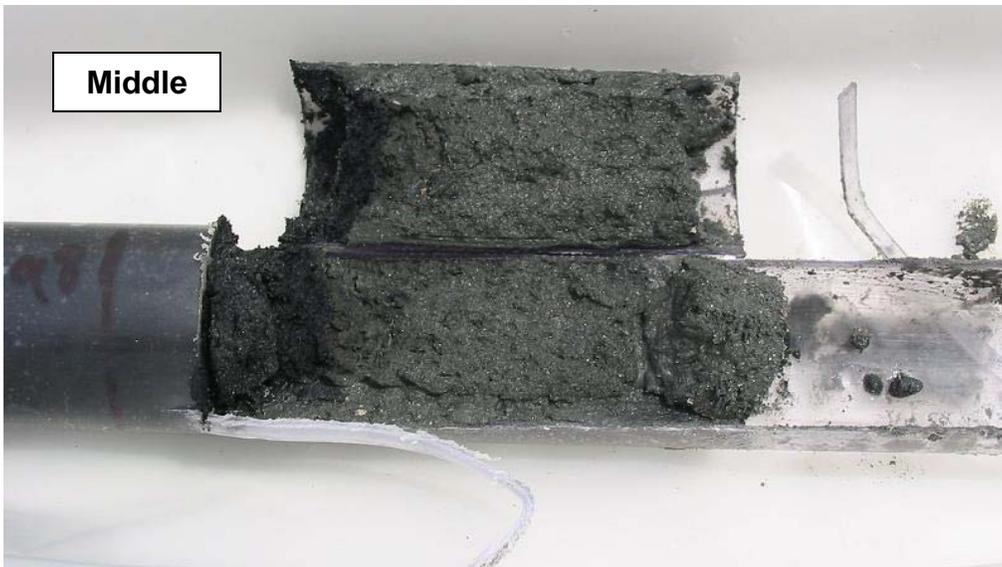
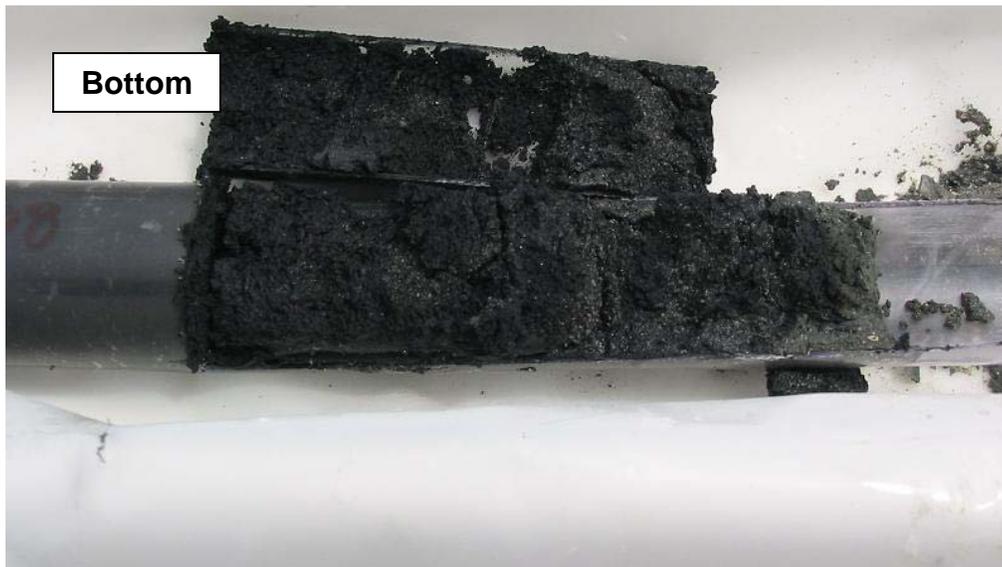
Figure 4-1
Example Sediment Core Photos
Source: ABC 2004

Cap layer material and LARE material remained visually unique as observed in Years 1 and 2. The SEIBP cap material is comprised of grey to dark grey sand, interspersed with large amounts of shell hash, and has no odor. The LARE material is black, soft silt interspersed occasionally with organic matter and contains an identifiable petroleum odor. During collection, the Navy divers noted that the layer of flocculent material on the surface of the cap had increased in depth to between 5 and 10 cm. The flocculent layer blanketed the entire cap area and numerous burrow mounds were present throughout the site. As with previous sampling events, the cores collected in Year 3 did not reflect the diver's visual observations of a fluffy flocculent material or the evidence of biological activity in the cap material. Digital photos are shown in Figure 4-1 and are representative of all cap site core samples.

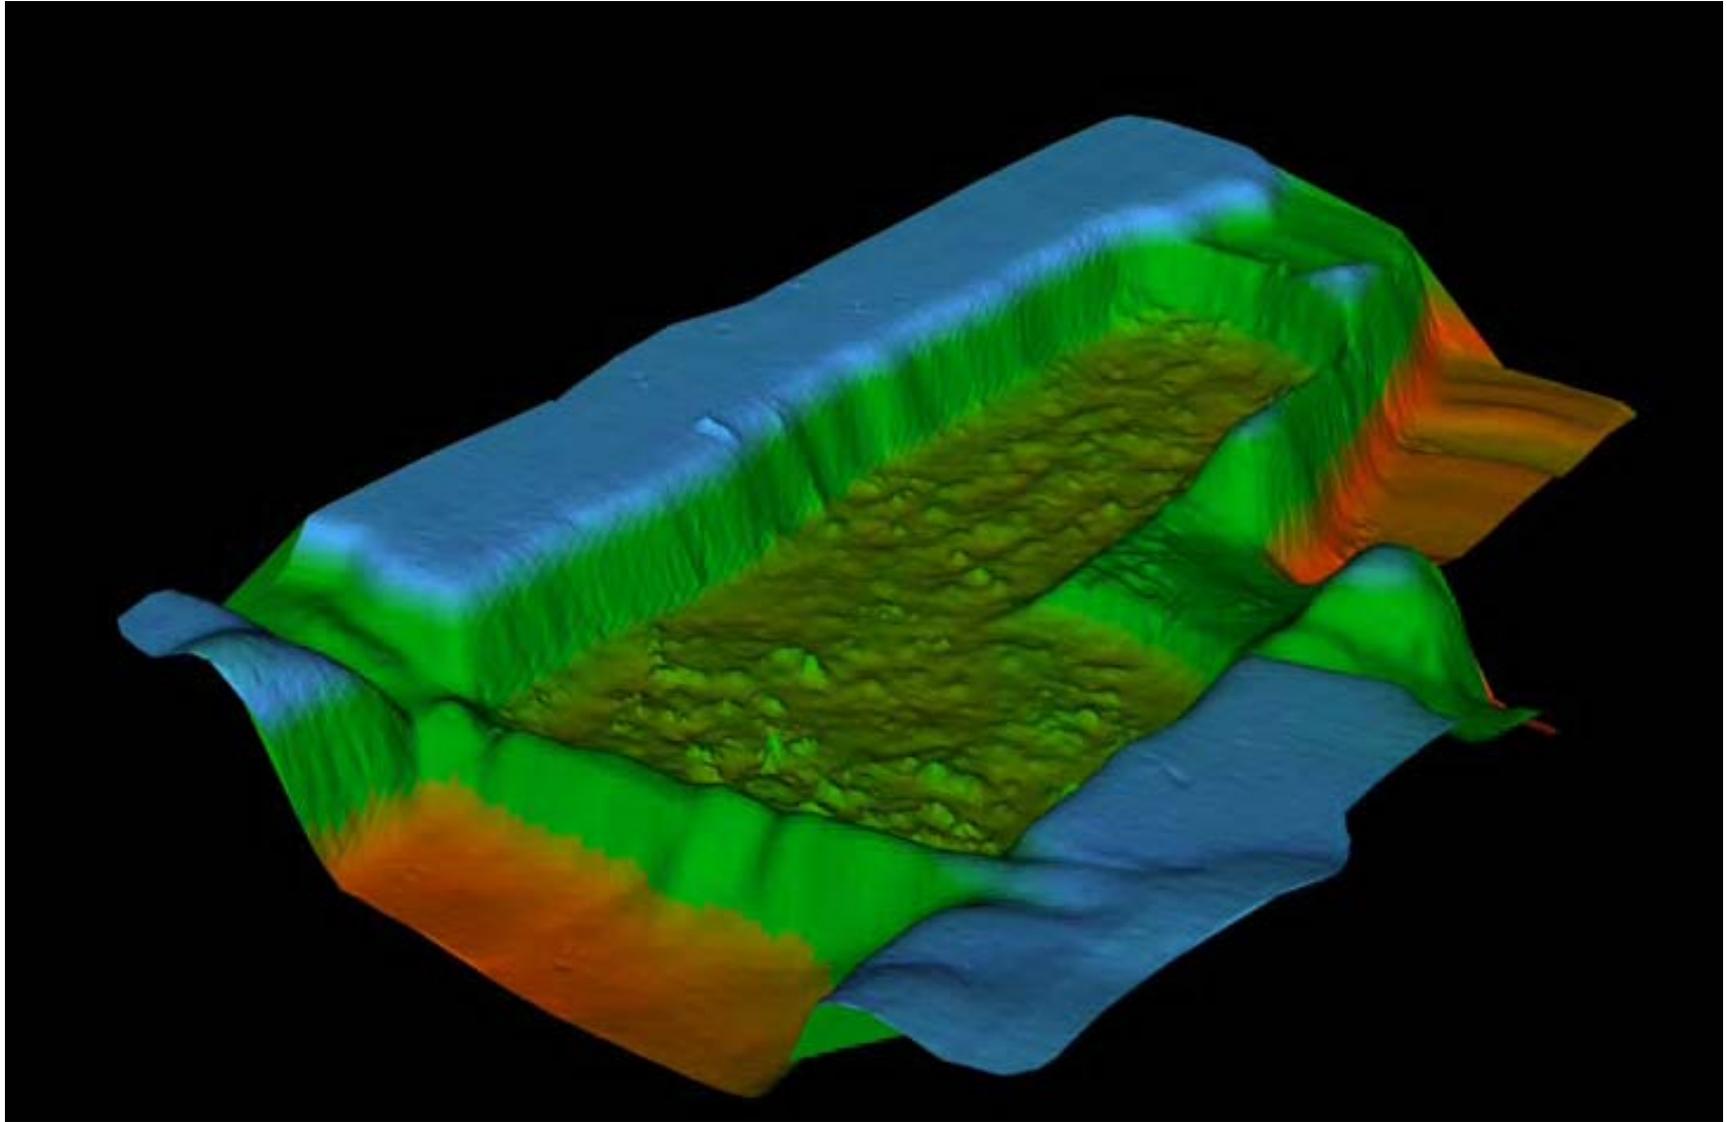
Figure 4-2
Year 3 Bathymetry Figure

Bathymetry survey results further indicate that the engineering design criteria of the project have been met and that the integrity of the cap has been maintained. The surface elevation of the cap site ranged from -12 to -14 m MLLW. Isopach thickness, comparing pre and post-placement of LARE dredge and SEIBP cap materials, showed that the thickness of the LARE material ranged from 1 to 2.5 m, and that the cap ranged from just under 1 to 2 m. Comparison of surface isopachs between Year 1 and Year 3 suggests that the surface of the cap is unchanged indicating that no significant erosion, consolidation, or sloughing had occurred. There was also no evidence of any fractures or large depressions that would impact cap integrity.

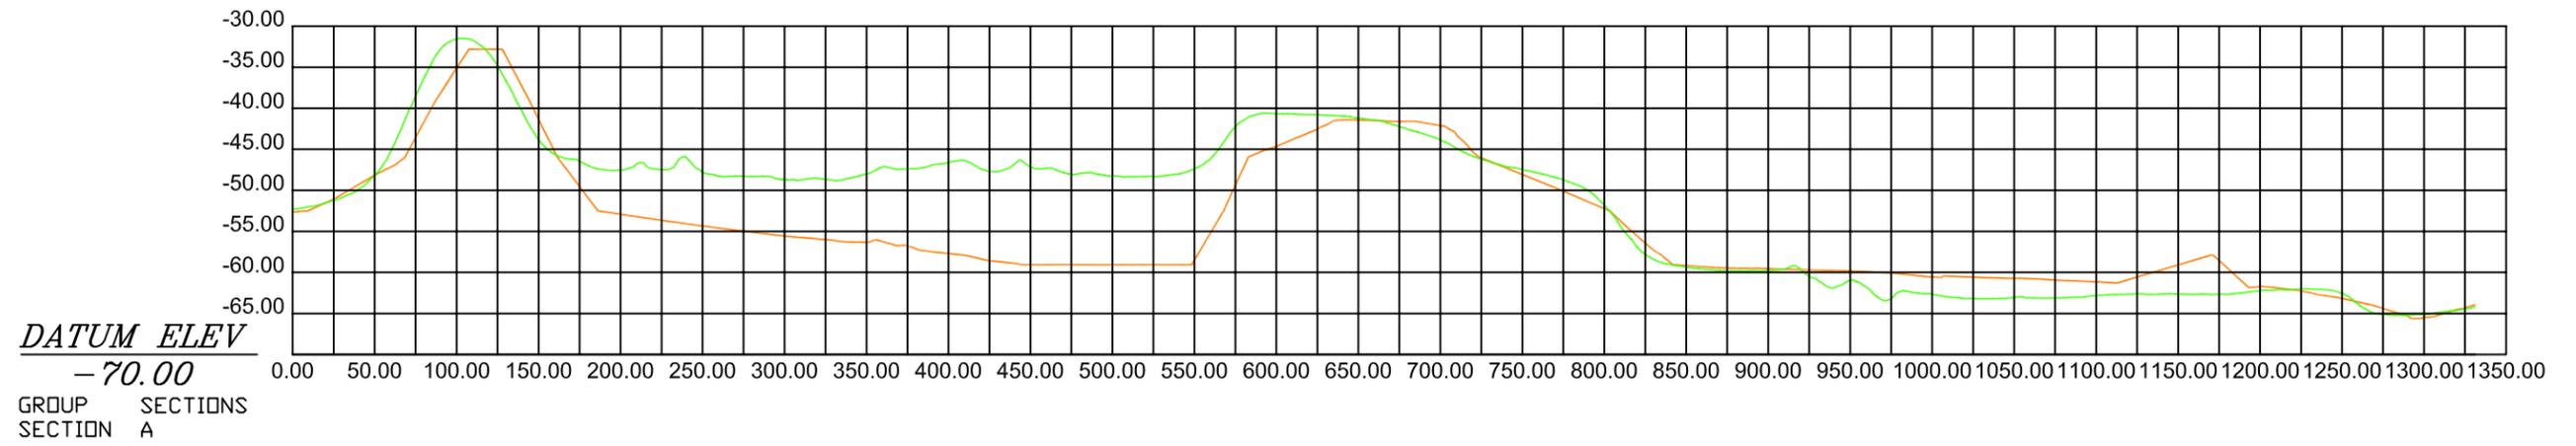
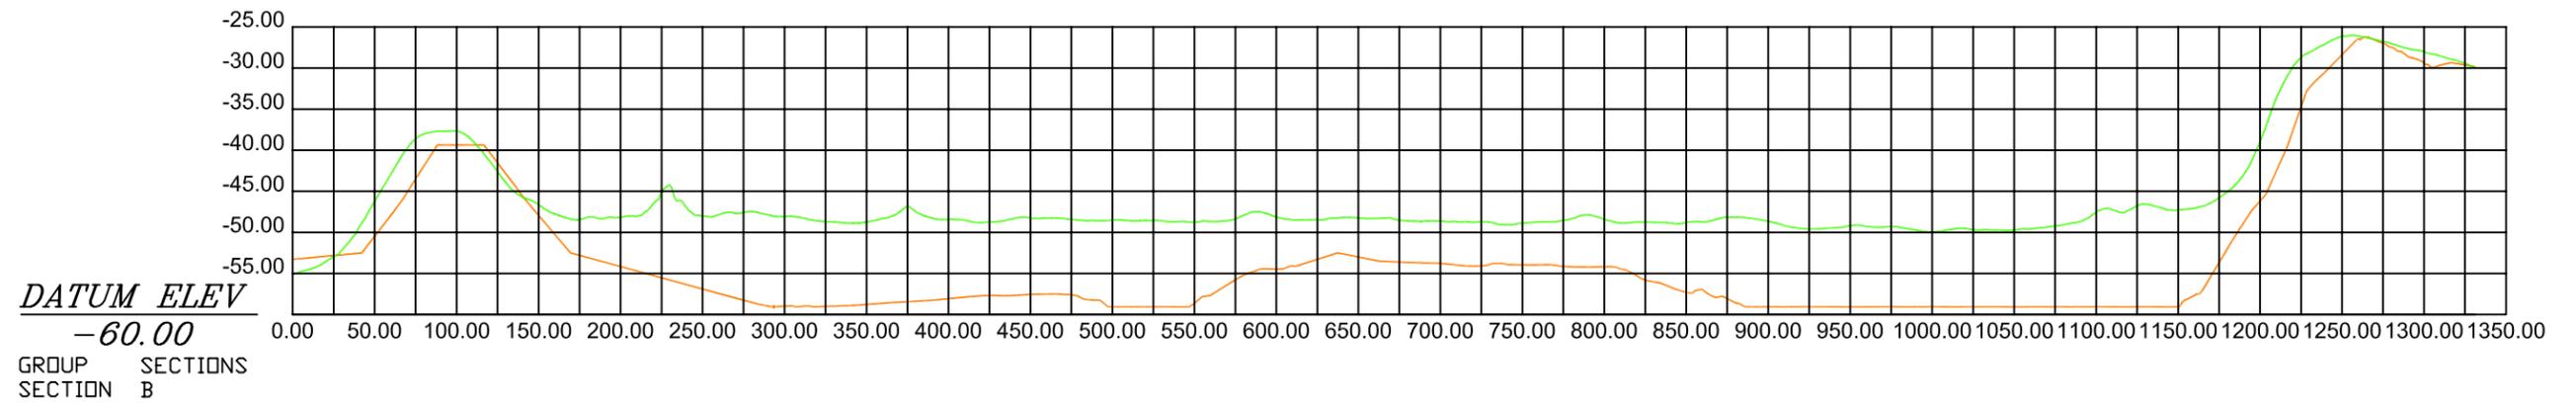
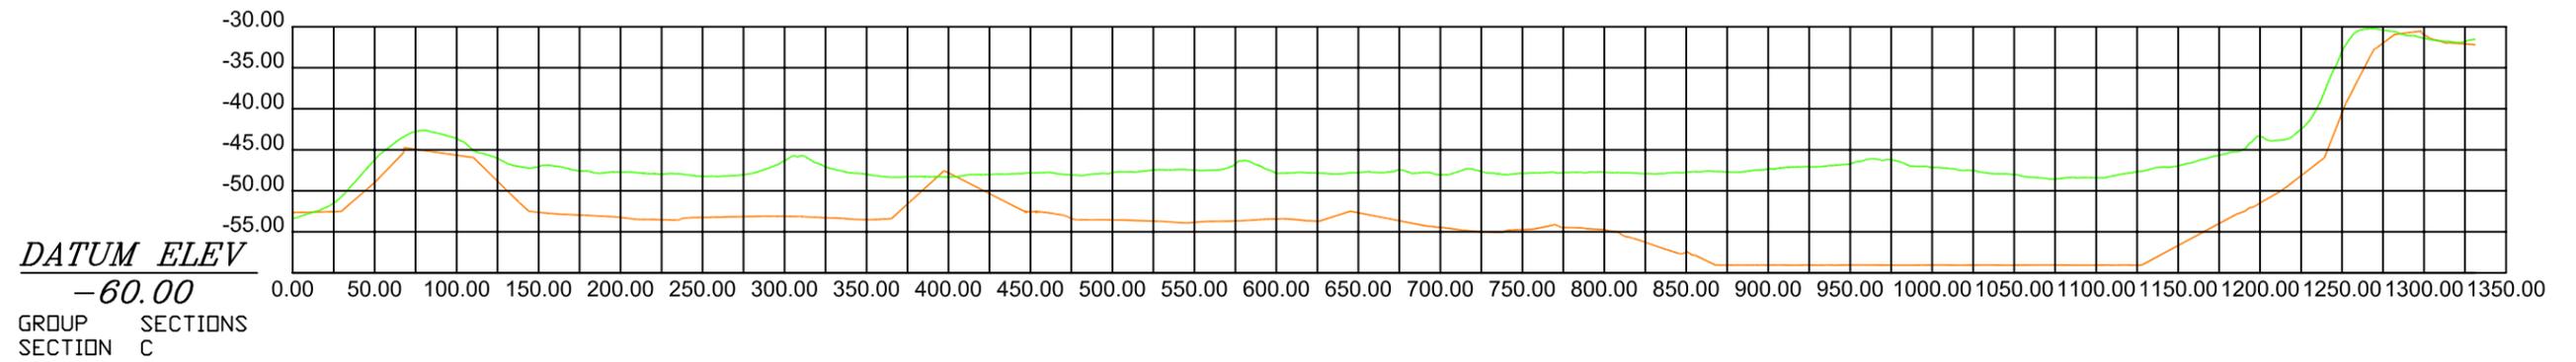
Post Construction to Year 3 Cross Sections a, b, c

- Cap Surface (Year 3)
- Cap Surface (Post Construction)

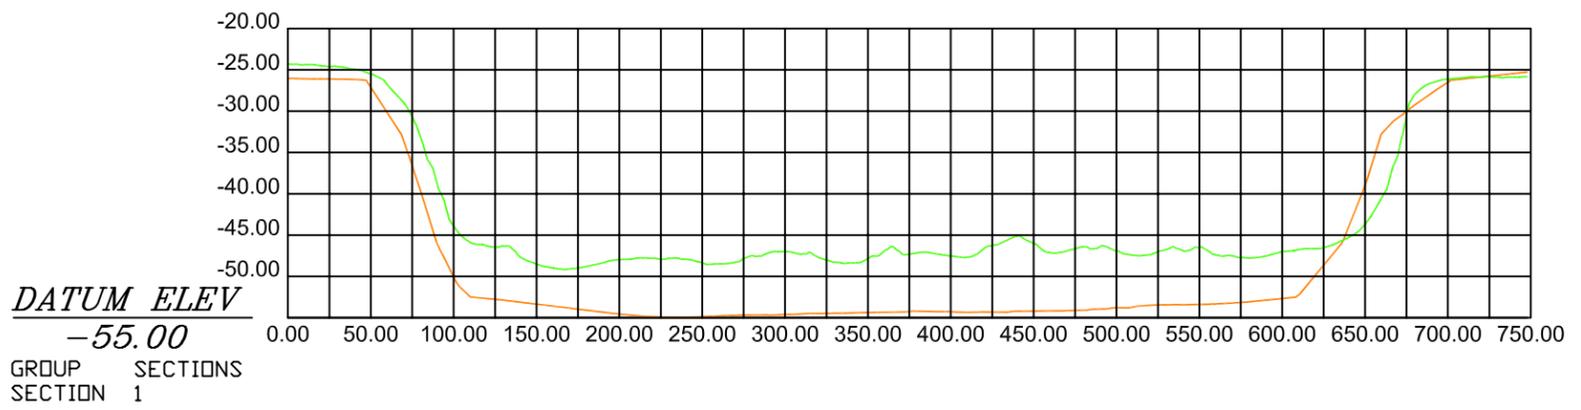
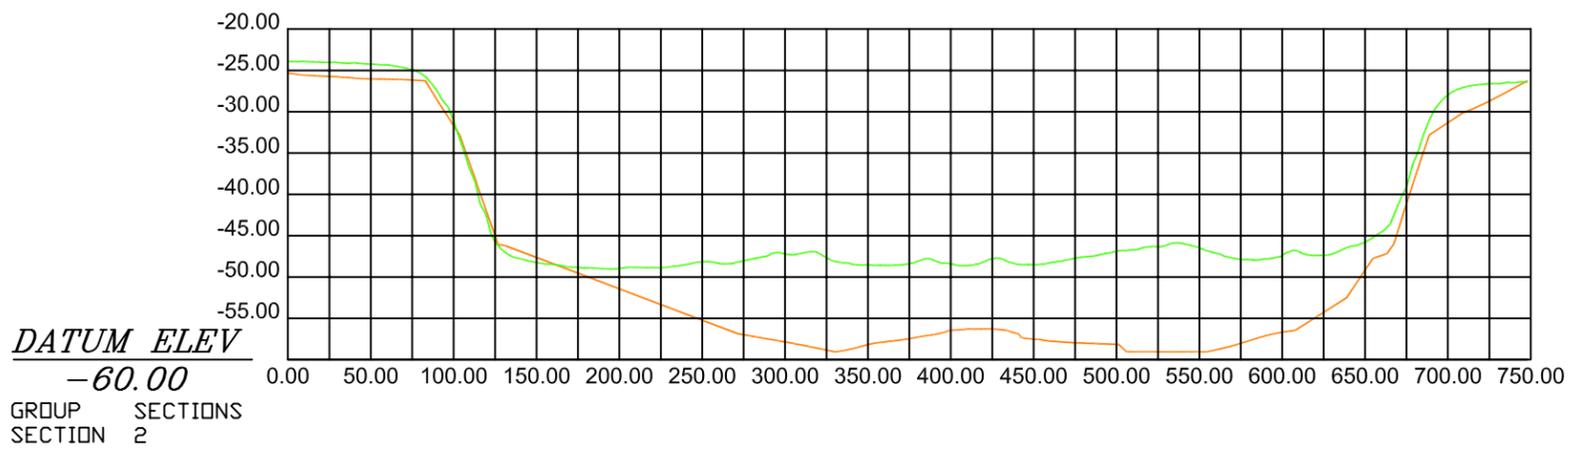
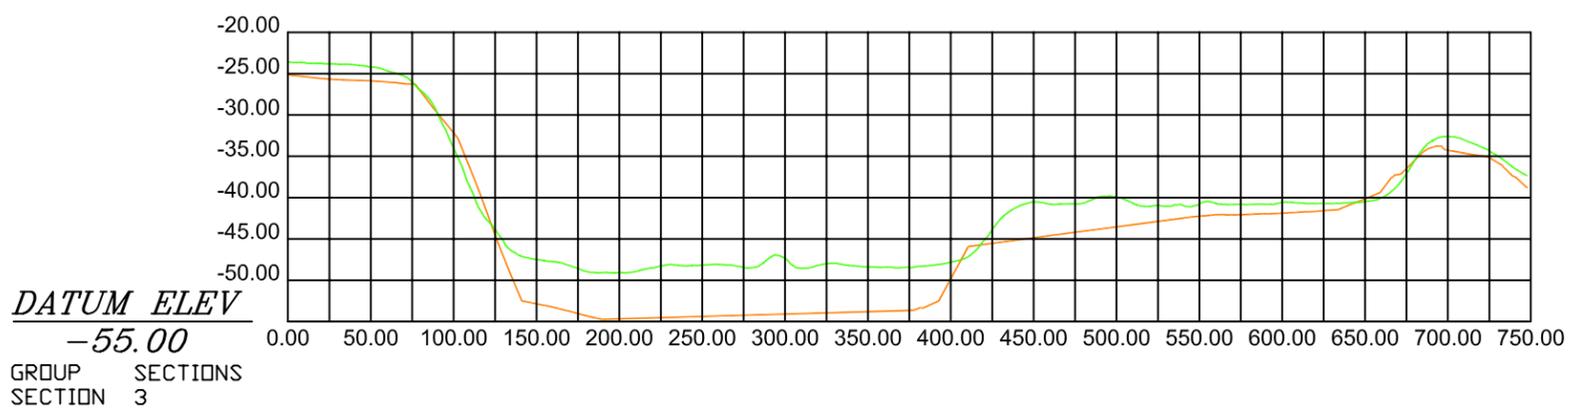
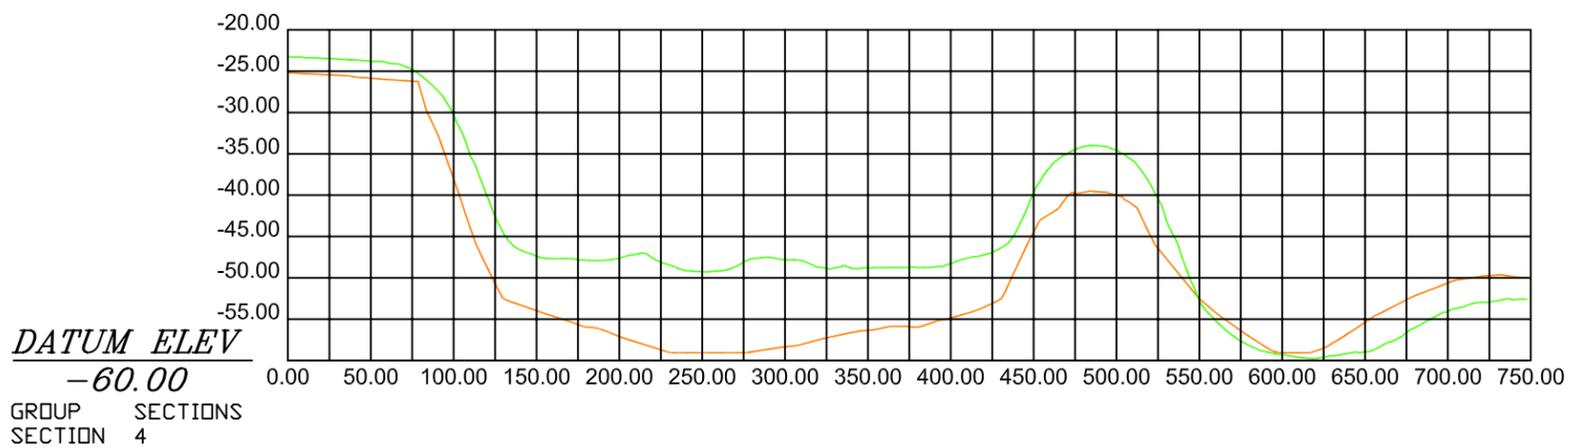
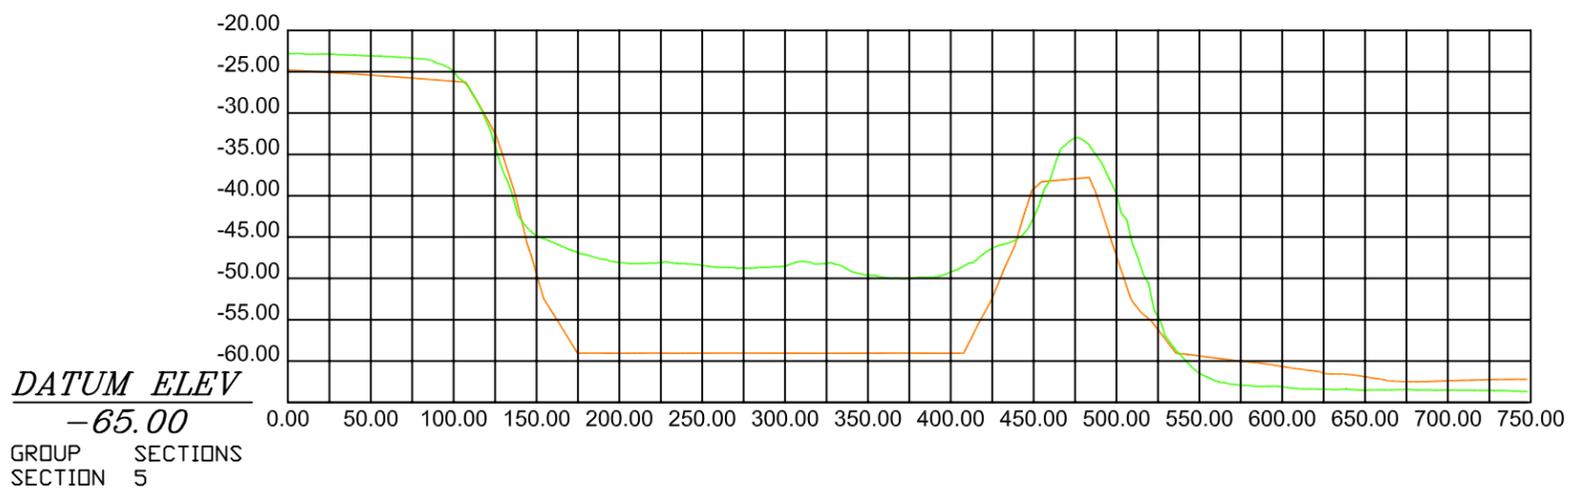
Figure 4-6
Post Construction to Year 3 Cross Sections 1,2,3,4,5

— Cap Surface (Year 3)
— Cap Surface (Post Construction)
